# Replacement zinc standing seam roof with solar PVs

**Project:** Princess Elizabeth Hospital, Guernsey – Lighthouse Wards

**Client:** States of Guernsey Health and Social Services Department

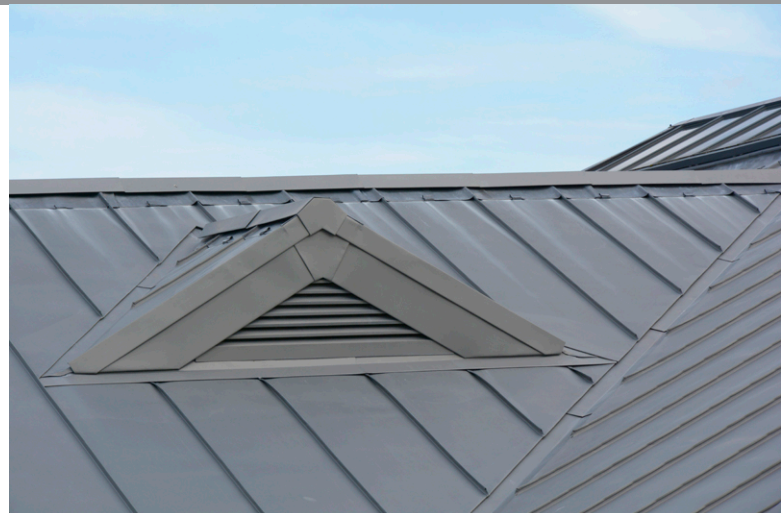
Some of the wards are also fitted with photovoltaic panels, which are very simple to install with a zinc

standing seam roof. Unlike tiles, the metal is self-cleaning so that there is no moss build-up under the panels.

The panels for the Lighthouse Wards were installed using the S-5-PV Kit, a fixing system which attached direct to the standing seams on the roof, producing no penetrations whatsoever and leaving a 40mm space underneath the panels which washes through with the rain. The installation was monitored by SIG Zinc & Copper who ensured that the cable penetrations were taken through the eaves and not the roof finish.

The S-5 fixings produce a PV installation which not only works well but also looks very neat and clean. The same fixing clips can also be used for man-safe systems and snow guards if required.
